SUBARU

PART NUMBER: H461SXC300

INSTALLATION INSTRUCTIONS

DESCRIPTION: Ascent Illuminated Cargo Sill

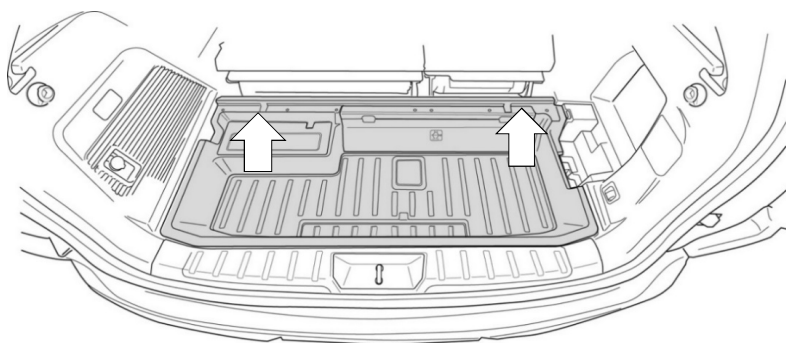
Step 4: Using trim tool detach clips and remove OE cargo sill.

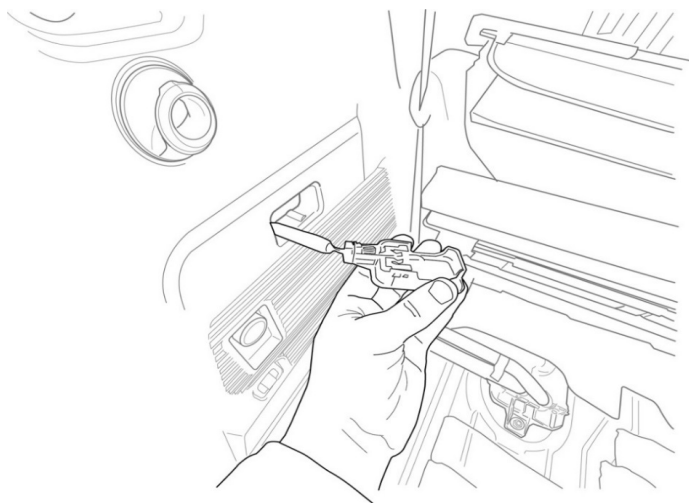
Step 5: Uncover and remove fastener located in D-ring cavity in LH side cargo panel.

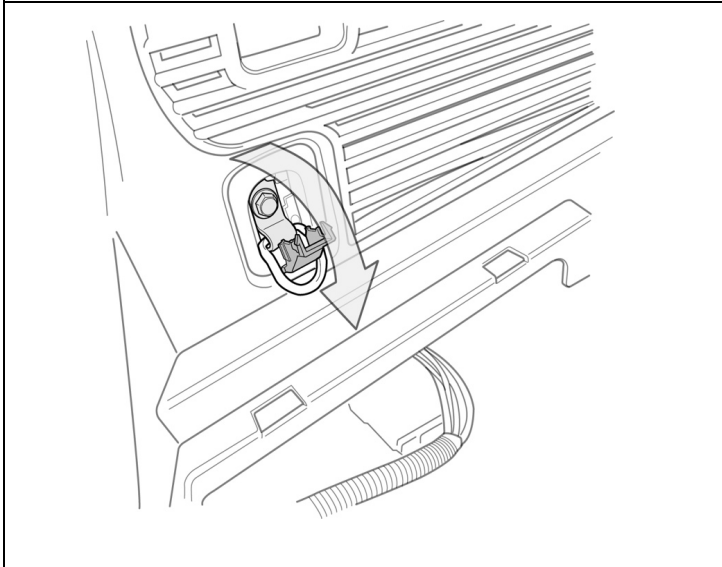
Step 7: Using the trim tool, disengage the clips securing the LH cargo panel to reveal courtesy lamp power connector.

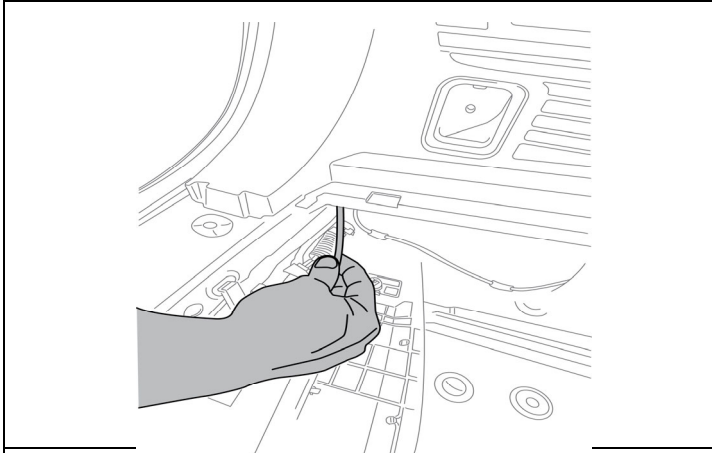
Step 13: Route harness as shown to avoid pinch by cargo panel.

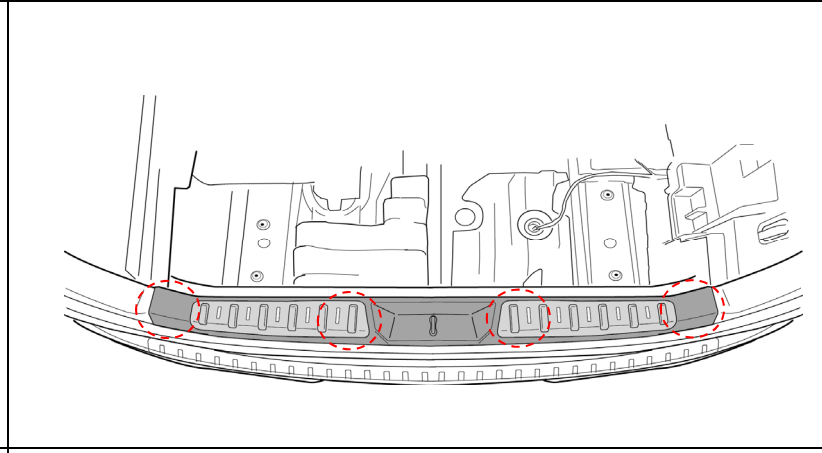
Step 14: Attach Illuminated Cargo Sill to vehicle with (x4) mating clips by applying even pressure.

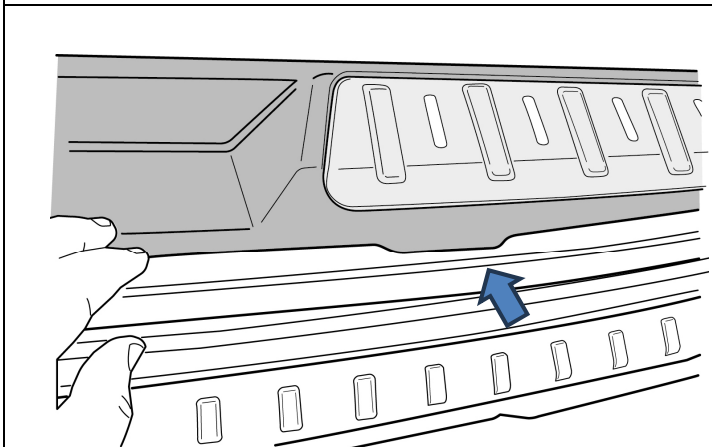
Step 15: Seal any pinched weather strip with trim tool or by hand.
